TWO-STAGE POTASSIUM TEST TURBINE

Volume IV

Materials Support of Performance
and Endurance Tests

Prepared under Contract No. NAS 5-1143 by
GENERAL ELECTRIC
Cincinnati, Ohio

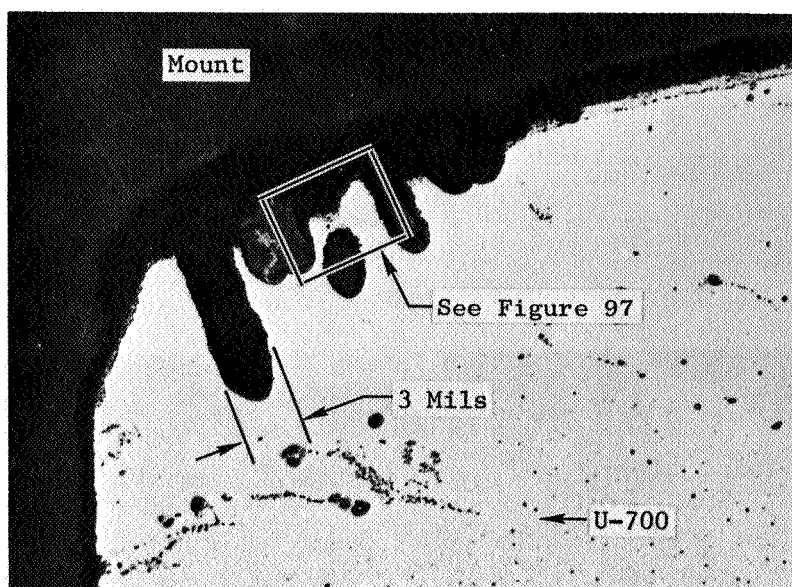
Figure 96. Impact Erosion Pits in U-700 Erosion Insert A-3 at a Second Planar Position. (B340113)

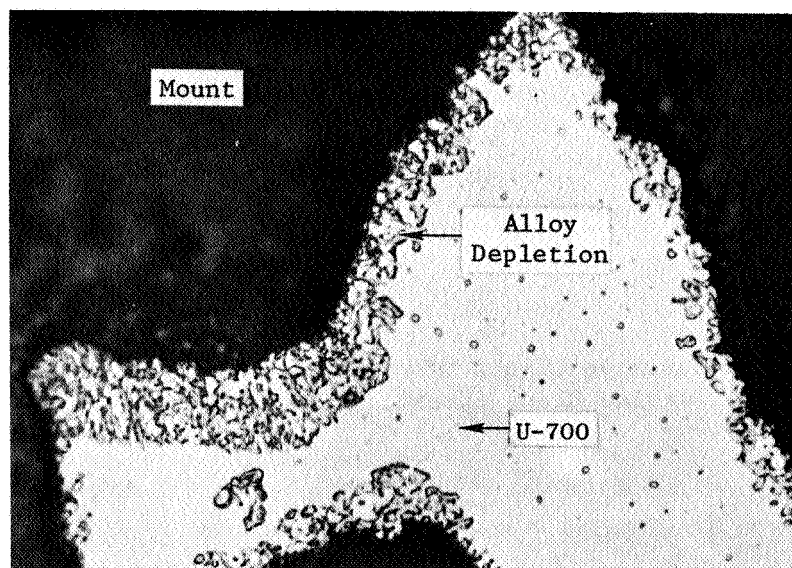
Figure 97. Alloy Depletion in Area of U-700 Impact Erosion Pits (See Above Figure). (B340115)

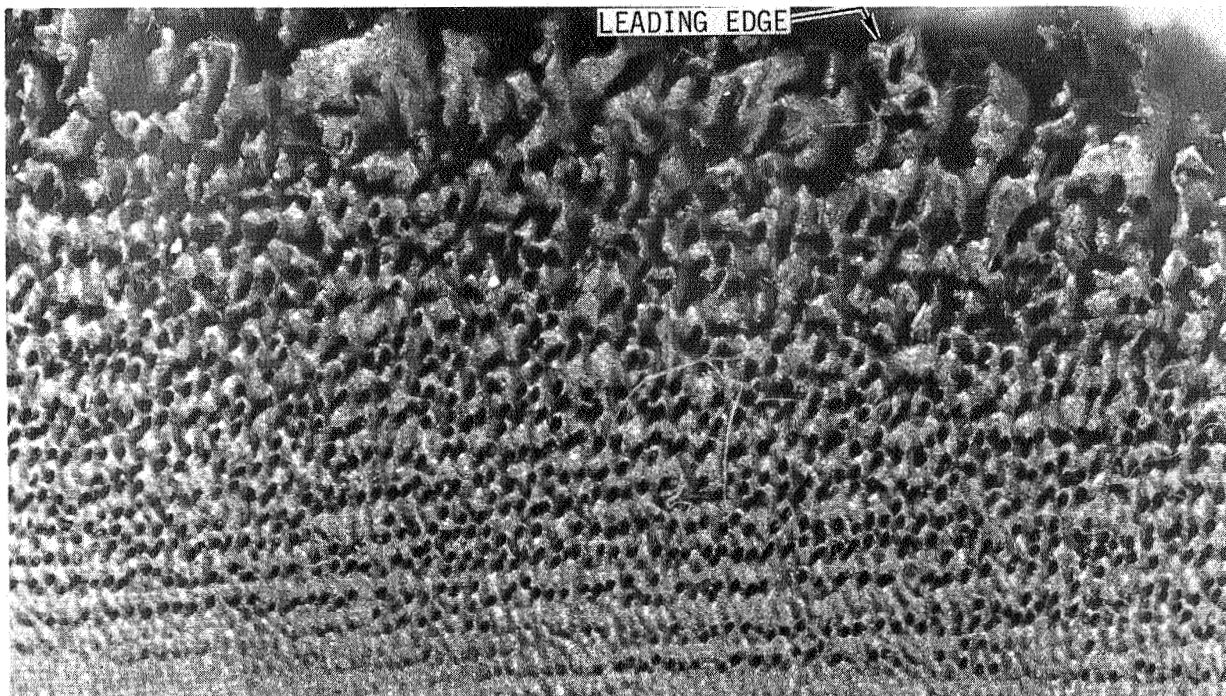
These erosion inserts gave the first evidence of what could be classical liquid droplet impact erosion in the U-700 specimens and similar in nature to steam turbine erosion as seen earlier in macro form in Figure 43, and at larger magnification in Figure 98. The deep holes formed in the exact area where droplets would have been released from the second stage trailing edge blade tips and would have impacted on the erosion insert. The micro-cracks at the base of the holes are indicative of the impact erosion or cavitation erosion methods or mechanical damage. The surface areas between adjacent holes deteriorated either by an apparent randomness in the location of impacting droplets or by disruption of the surface between adjacent holes. At the periphery of the cluster of holes there existed occasional deep holes, with depths 4 to 5 times that of their diameters; these holes had formed in the original surface of the U-700 insert without doing damage to the adjacent surface. This type of erosion was similar to that reported by Hays⁸ for ductile materials in steam turbine erosion. In other examples of erosion, pits in otherwise unaffected surfaces have been noted in multiple droplet impact specimens and in cavitation damaged specimens. In water droplet impact in Stellite 6B erosion shields in steam turbines, deep pits or irregular cross section have been observed with depths of one to two diameters in areas where no adjacent surface damage was noted.

Figure 98. Characteristic Liquid Droplet Impact Erosion on Stellite 6B Steam Turbine Blade Insert. (C65061410)

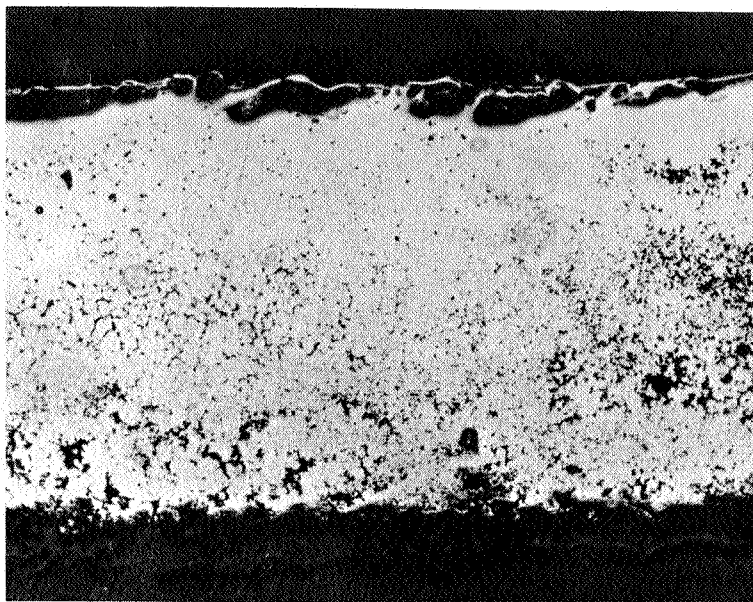
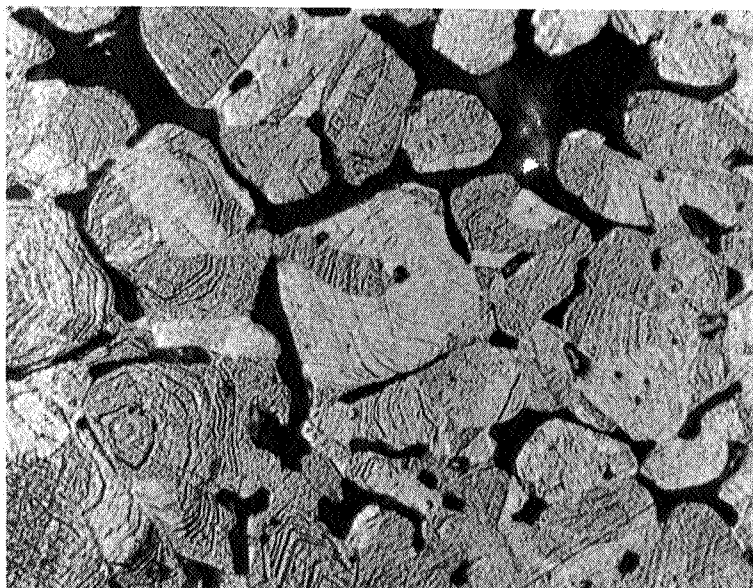
When the convergent-divergent nozzle test section was removed for flange modifications in November 1963, a thick metallic deposit occurred on the far side of the inside surface of the elbow leading into the condenser. The deposit was thickest directly opposite the nozzle, and from that location thinned-out in all directions. The deposit, at its thickest, measured approximately 0.030-inch, and appeared to consist of large laminated particles sintered together. Photomicrographs showing the structure of this deposit are presented in Figure 102. Qualitative spectrographic analysis of the deposit indicated a major concentration of nickel (greater than 10%), a minor concentration of iron (less than 10%) and trace concentrations of chromium, aluminum and cobalt (less than 1%).

Figure 102. Cross Section of Metallic Deposit from CD Nozzle Test, 100X (Top); Enlarged and Etched Section of Metallic Deposit from CD Nozzle Test Showing Vapor Deposition Characteristics, 1000X (Bottom). (C63121252)

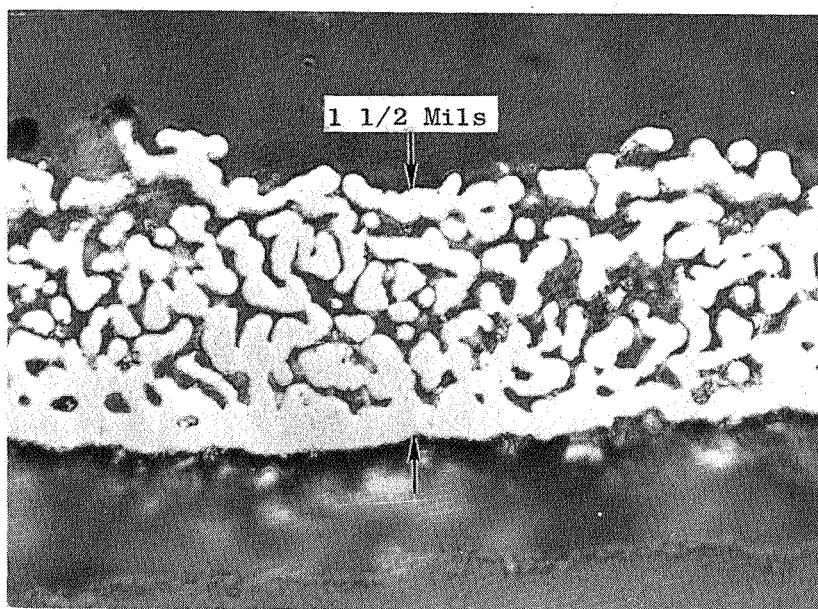
The metallic, mass-transfer deposits which occurred during performance testing were observed in several places. A foil deposit on the 8-inch turbine inlet vapor line immediately downstream of the throttling valve resulted when liquid droplets containing metallic elements in solution were dried-out as they passed through the partially closed valve. This foil deposit was porous and appeared to have grown from the evaporation of liquid droplets and not as impacted, or sintered solid particles of the type previously observed in the convergent-divergent nozzle test. The foil thickness ranged between 0.005-to 0.010-inch thick. The texture of the foil deposit from the 8-inch line is shown in Figure 103.

Figure 103. Metal Foil Removed from the 8-Inch Vapor Line of the 3000 KW Turbine Facility After Performance Testing. (A680111)

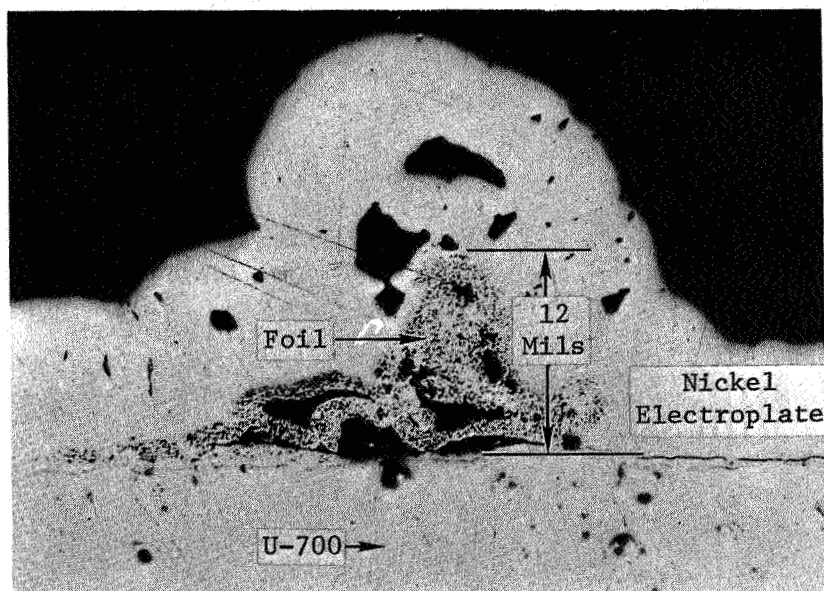
During performance testing, after the facility had been modified to supply drier vapor, a portion of foil deposit, of the above origin, became detached from the inner surface of the 8-inch line and was carried downstream by the high velocity potassium vapor to be re-deposited upon surfaces such as the refractory alloy specimen probe and the inlet guide vanes. Figure 104 shows the nature of foil deposits on the first stage nozzle diaphragm. Figure 105 shows some of these foil particles on the convex side of the first stage turbine blades and to a very minor extent on the second stage blades. Apparently, the foil was ground into very small particles within the first stage, allowing most of these fine particles to pass through the second stage without becoming attached to the airfoil surfaces. The microstructure of impacted foil deposits on the convex airfoil surface of a first stage blade is shown, at two magnifications, in Figures 106 and 107. These foil deposits on the blades were identical in texture to the foil pieces taken from the wall of the 8-inch vapor line downstream of the throttling valve.

Figure 106. Foil Deposit Impacted on a Stage One Blade During Performance Testing. (A610111)

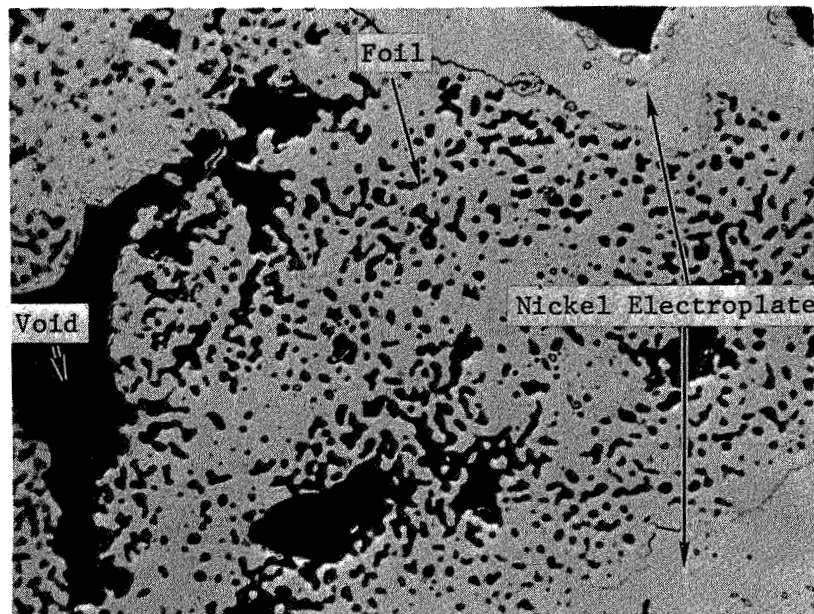
Figure 107. Foil Deposit Impacted on a Stage One Blade During Performance Testing (A610117)

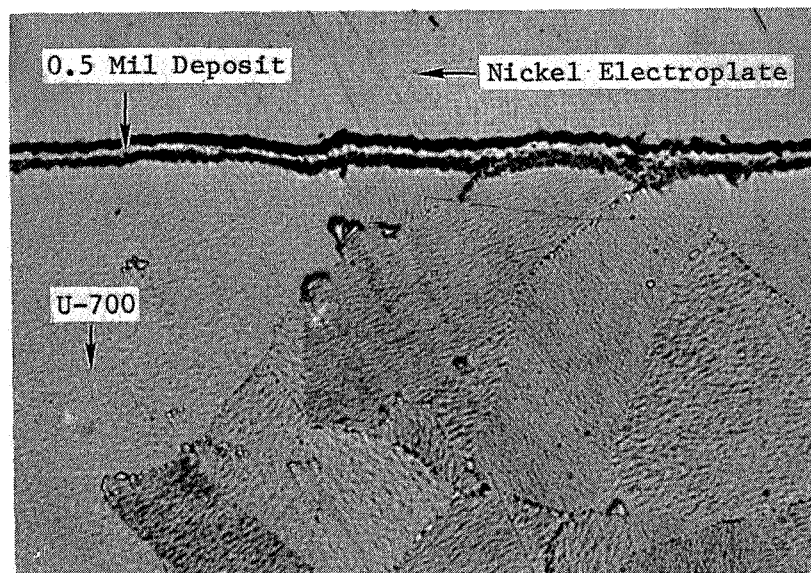
In addition to the presence of impacted metallic foil on the turbine blades, which was noted after performance testing, thin metallic films formed directly on the blades from the evaporation or cooling of liquid droplets in two separate instances. First, very minor traces of such deposits were found on the grossly corroded turbine blades after the first period of turbine checkout, in which the film was detected by electron microprobe analysis. Second, during the 12- and 56-hour periods of performance testing, in which corrosive liquid potassium was not sprayed into the vapor line, a uniform, but thin film of deposited metal accumulated on the airfoil sections of blades from both stages in the turbine. The uniform film thickness on the first stage blades was 0.5-mil as seen in Figure 108 and only 0.2-mil on the second stage blades as seen in Figure 109. As the result of pickup of metallic elements, the first stage blades experienced an average weight gain of 1.13% per blade and the second stage blades gained an average of only 0.023% per blade.

Figure 108. Uniform Metal Film Deposit on a First Stage Blade After 65-Hour Performance Test. (A61011-10)

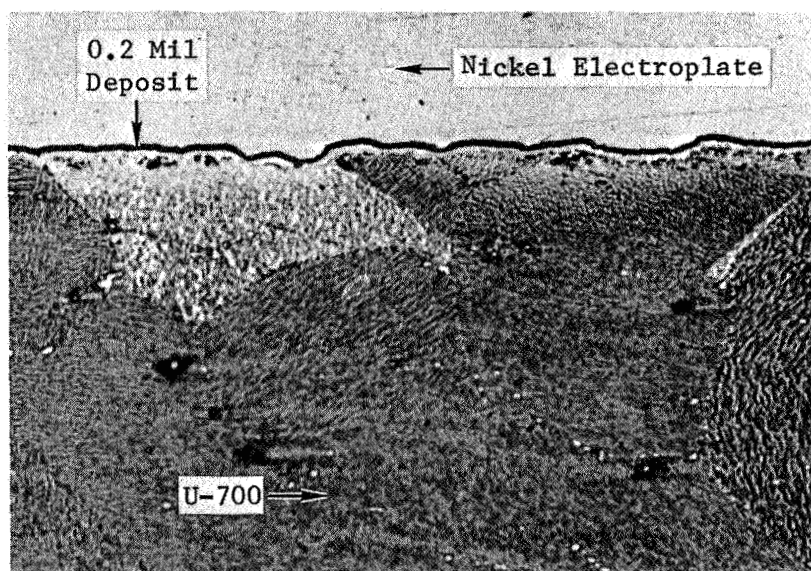
Figure 109. Uniform Metal Film Deposit on a Second Stage Turbine Blade After 65-Hour Performance Test. (A750118)

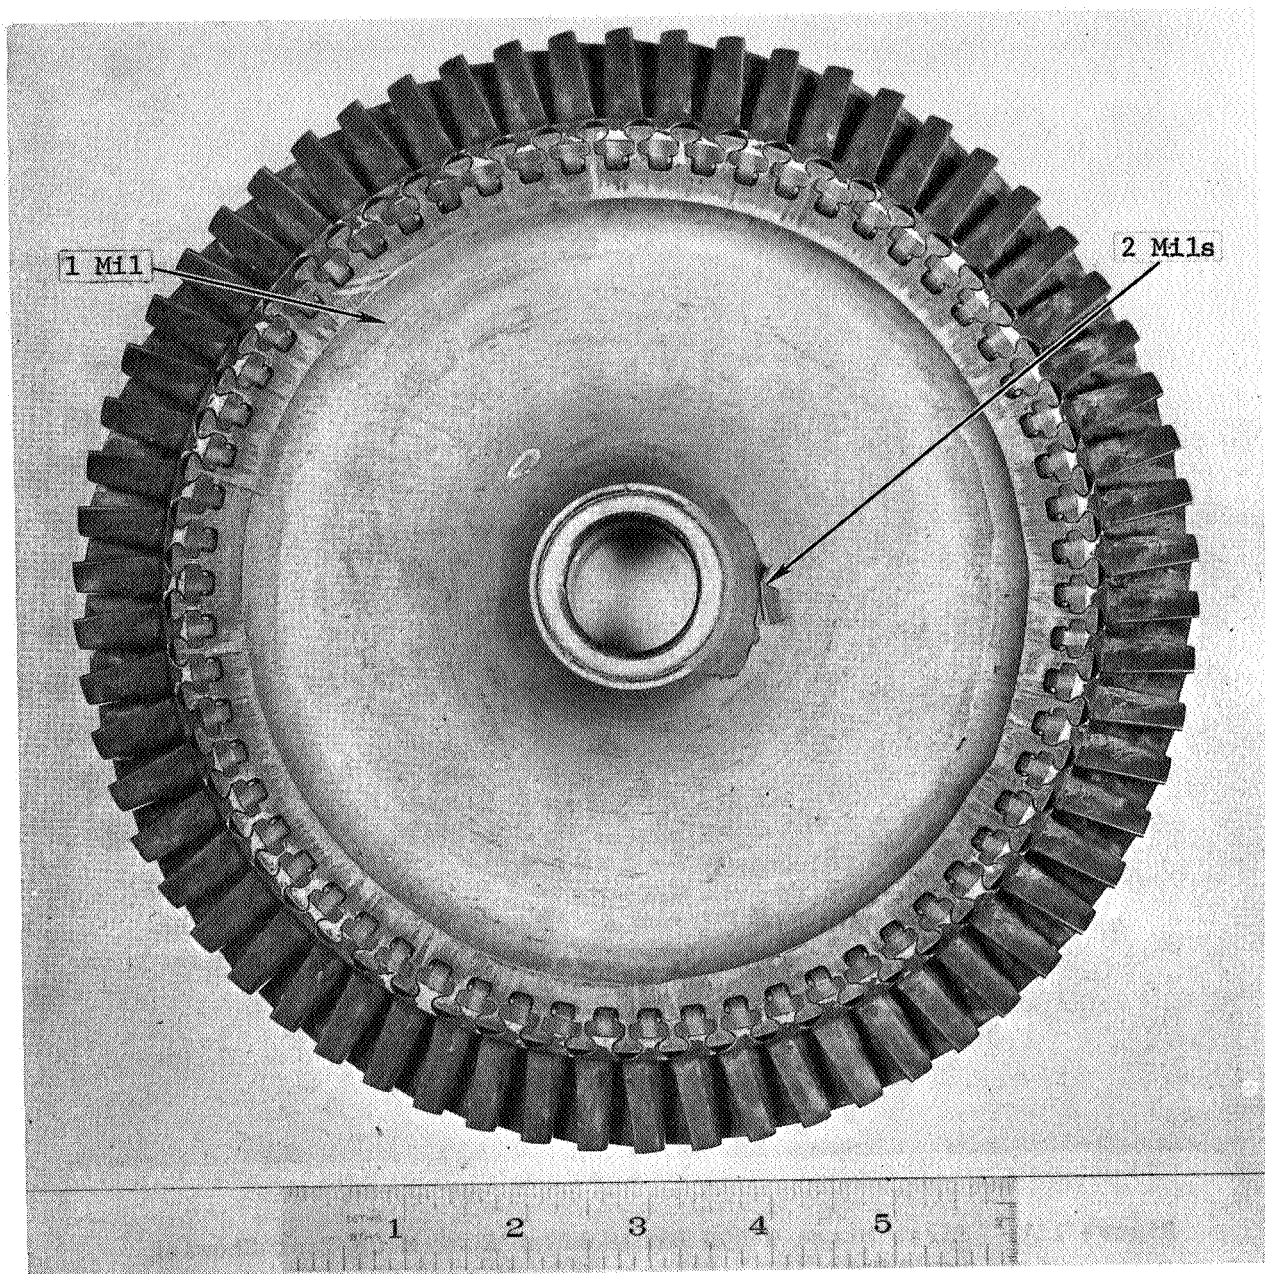
Minor deposits of metal accumulated on the first stage wheel surface and on turbine blade airfoil sections as shown in Figures 110 and 111. It was expected that the metallic deposits which formed on the first stage wheel and blade surfaces during endurance testing were produced by evaporation or cooling of liquid droplets carried over from the boiler. However, the chemical analysis, also presented in Table XV, shows a significant amount of

Figure 110. Forward Face of First Stage Turbine Wheel After 2000 Hour Endurance Test Showing Deposited Metal Film. (C65123043)

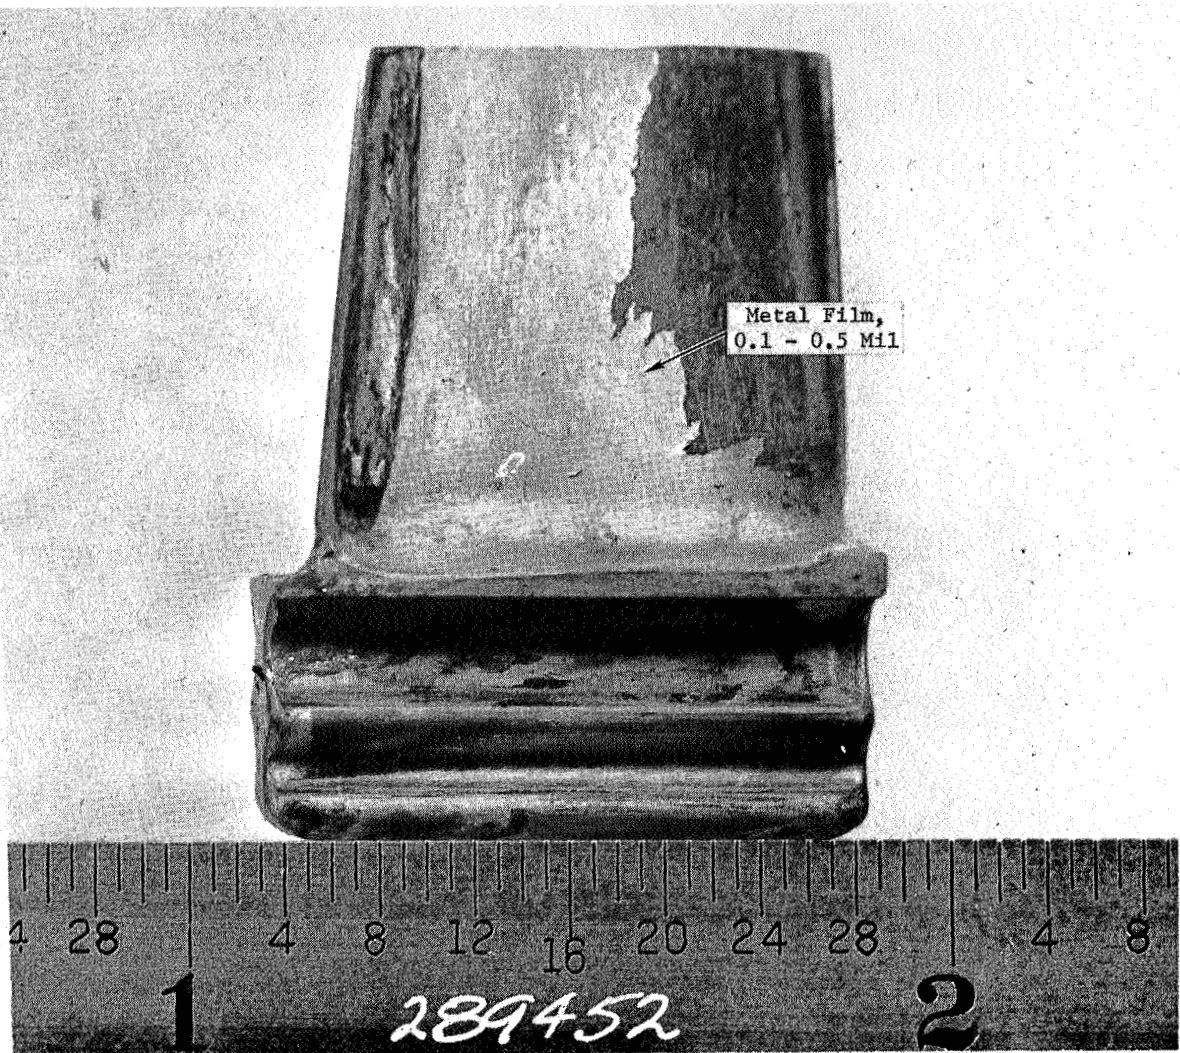
Figure 111. First Stage U-700 Blade After 2000 Hour Test Showing Deposited Metal Film. (289452)
